RESEARCH ARTICLE

Development of Vegetation and Aquatic Habitat in Restored Riparian Sites of California's North Coast Rangelands

Michael S. Lennox,^{1,2} David J. Lewis,¹ Randall D. Jackson,³ John Harper,⁴ Stephanie Larson,¹ and Kenneth W. Tate⁵

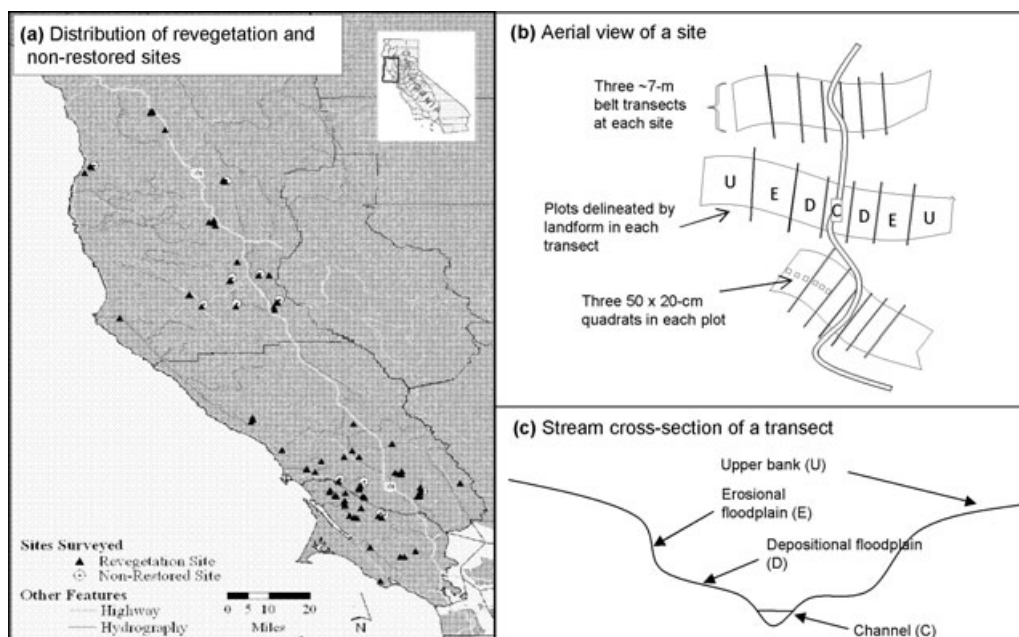
Figure 1. The three county study areas north of San Francisco Bay including locations of restored and nonrestored survey sites (image courtesy of Sonoma County GIS Central) a). Aerial view of an idealized survey site depicting belt transects, plots delineated by landform, and herbaceous quadrats b). Stream channel cross-section showing landforms along a transect c).

We surveyed 102 sites in Marin, Mendocino, and Sonoma Counties (Fig. 1). Sites were selected in collaboration with consultants, agencies, and landowners, whose permission was solicited for access to conduct surveys. Project cooperators identified both “successful” and “unsuccessful” projects to be included in the study. Site selection focused on projects with documented implementation dates in alluvial stream reaches of willow and mixed oak woodland vegetation with few trees present prior to project installation (e.g., Fig. 2a). Surveyed project sites were primarily on second- and third-order streams with a range in project age from 4 to 39 years since restoration.

We characterized riparian forest and aquatic habitats at riparian restoration project sites using 36 ecological attributes collected at 5 nested spatial scales: (1) site ($n = 102$, Fig. 1a), (2) belt transect ($n = 3$ per site, Fig. 1b), (3) landform class ($n = 4$ per transect, Fig. 1c), (4) plot ($n = 2+$ per landform), and (5) quadrat ($n = 3$ per plot, Fig. 1b). Landform classes were delineated by channel morphology and depositional or erosional features adapted from Harris (1987, 1999). Specifically, we used the lowest observed bankfull location and flood-prone elevation ($2 \times$ bankfull depth) described by Rosgen (1996) to delineate plots in the active floodplain. The final plot sampled on each bank extended from the top of the bank to the fence or field edge, and included alluvial

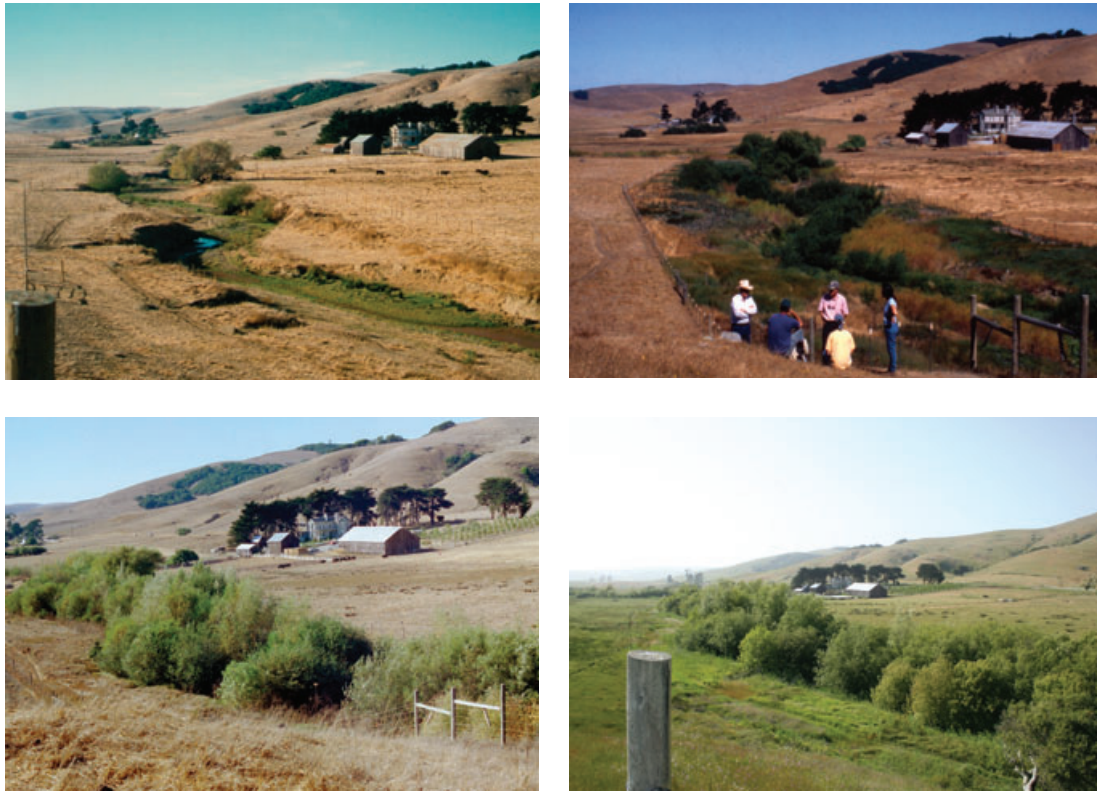
Figure 2. Photographic time-series of an example project site on a tributary to Walker Creek in Marin County, documenting vegetation response at 0 a), 2 b), 8 c), and 12 years d) since restoration occurred (images courtesy of Marin Resource Conservation District).

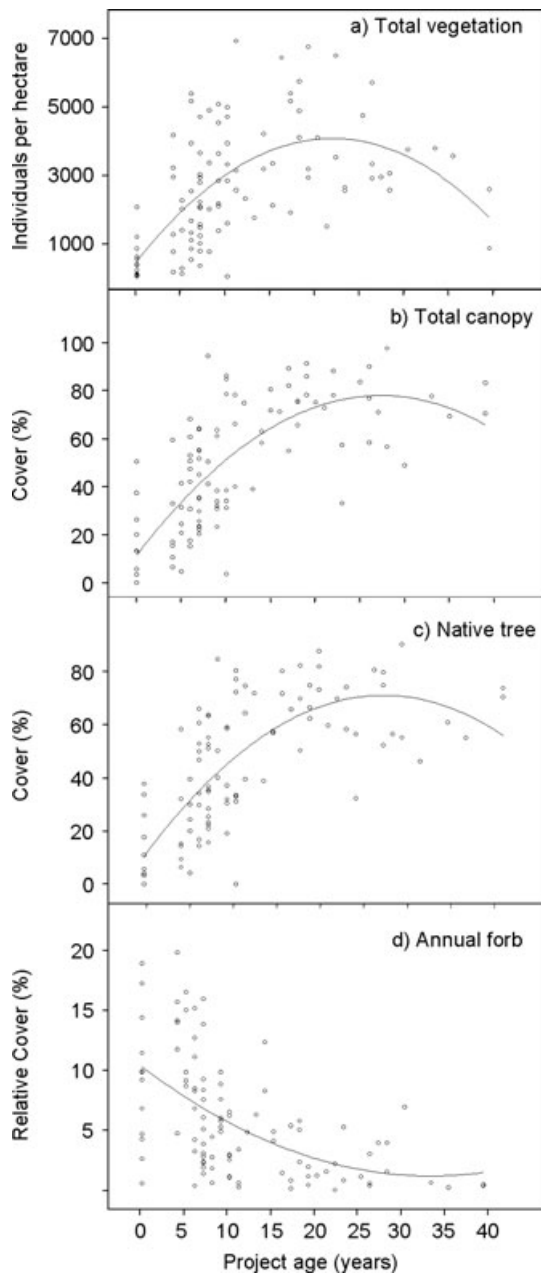
Figure 3. Vegetation attributes as a function of project age ($n = 102$) for total woody density a), total canopy cover b), native tree cover c), and annual forbs relative cover d).

increased. Of all these significant relationships, the best fits were total canopy cover and native tree canopy cover (Fig. 3).

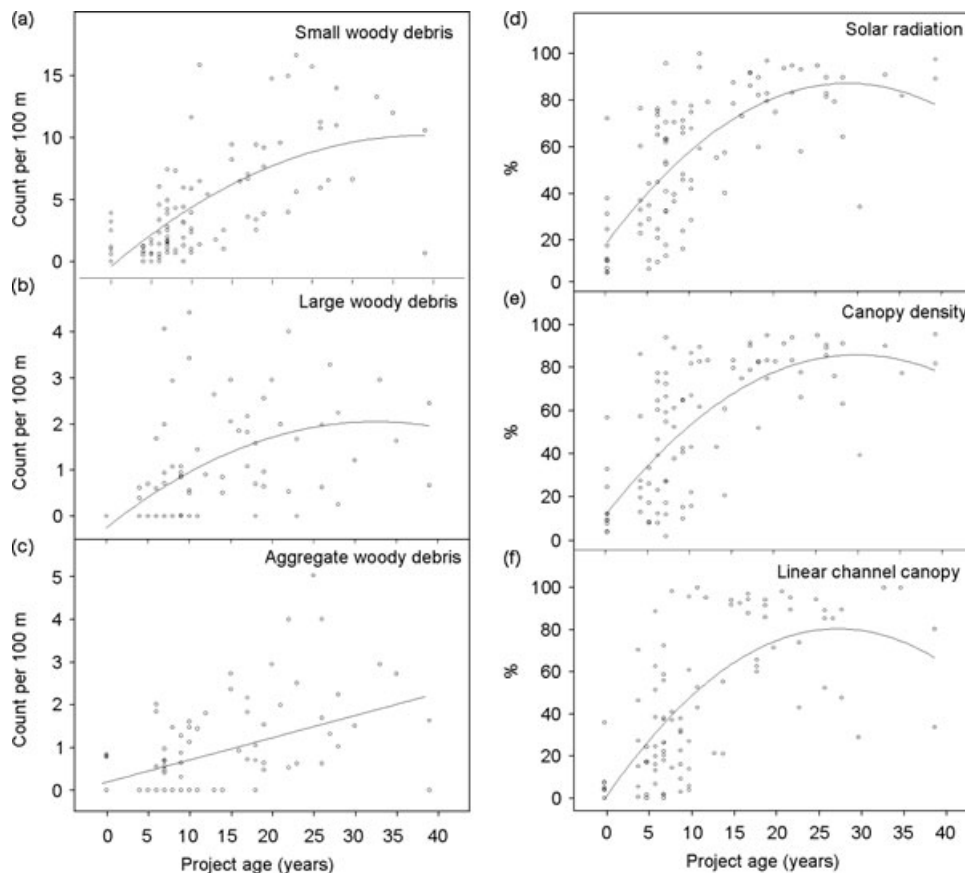
Figure 4. Aquatic habitat attributes as a function of project age ($n = 102$) for small woody debris a), large woody debris b), aggregate woody debris jams c), intercepted solar radiation d), canopy density e), and linear channel canopy f).

Significant relationships with project age were observed for 11 of 15 aquatic habitat metrics, including eight positive and three negative trajectories (Table 2). Stream channel morphology results had significant trajectories for five of the six attributes. The width-to-depth ratio of the bankfull channel had a negative linear relationship with project age. Streambank stability had a positive curvilinear relationship with project age and no relationship was found for bank slope angle. The three woody debris frequency metrics increased over time (Fig. 4). Small and large wood frequencies were best described by curvilinear relationships with project age, while aggregate debris jams of wood were best described by a linear relationship.

Water column attributes had significant trajectories for six of the nine investigated. Stream shade metrics, including intercepted solar radiation, canopy density, and linear channel canopy all increased curvilinearly over time (Fig. 4). Fine sediment and embeddedness showed no significant trajectory. Pool habitat metrics that had curvilinear relationships with project age were maximum and mean pool depth as well as pool habitat type. Pool frequency was not significantly related to project age (Table 2).
